# The Radar They Replaced for Nothing

A brand-new radar came out of the box eight degrees off, and the one before it probably had too.

## SUMMARY

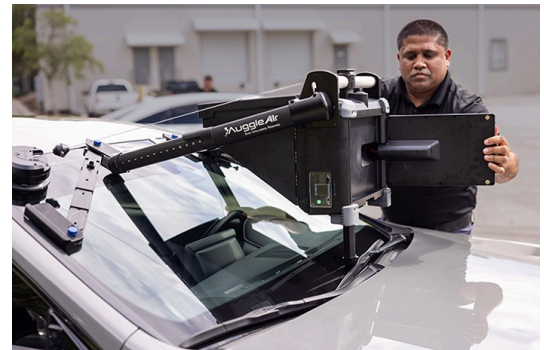
AIRPRO'S *AUGGIE AIR* DIGITAL TARGETING DEVICE, MOUNTED ON THE WINDSHIELD AHEAD OF A CALIBRATION
