# They'd Unplugged Everything Except the Sensor

Three components live under that seat, and the yellow connector is not the one you are looking for.

## SUMMARY

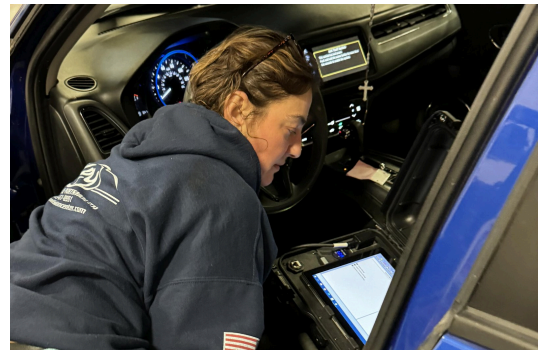
INSIDE THE CABIN WITH THE SCAN TOOL CONNECTED; THE OCCUPANT DETECTION PARTS SIT UNDER THE PASSENGER SEAT
